The power supply in this digibox has several common faults, some of which call for multiple component replacement. Michael Dranfield describes fault diagnosis and the action required

# DRX400 PSU problems

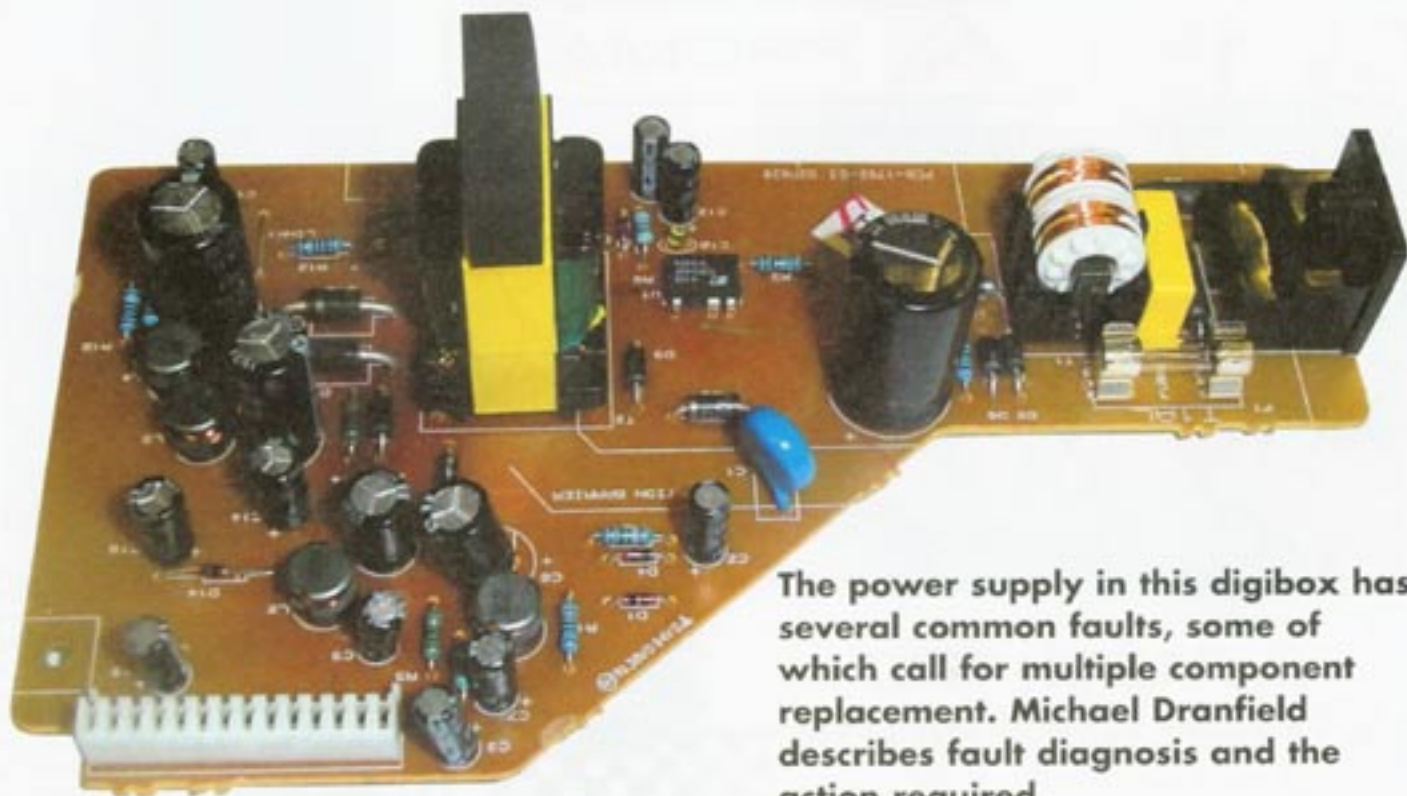
The heading photo shows the Amstrad DRX400's power supply.

The Amstrad DRX400 digibox is becoming a regular visitor to the workshop now that it's out of warranty. Apart from failure of the Connexant CX24108-20ES front-end ZIF tuner chip, which causes signal problems, most faults occur in the power supply. As with earlier Grundig digiboxes, most failures here are caused by the use of poor-quality electrolytic capacitors.

As a result of the experiences described above, SatCure has produced two reliability kits, one to upgrade the primary side of the power supply and the other for the secondary side. The part numbers are RELKIT42 and SATKIT42. To order, or for further details, go to the website at [www.satcure.co.uk](http://www.satcure.co.uk)

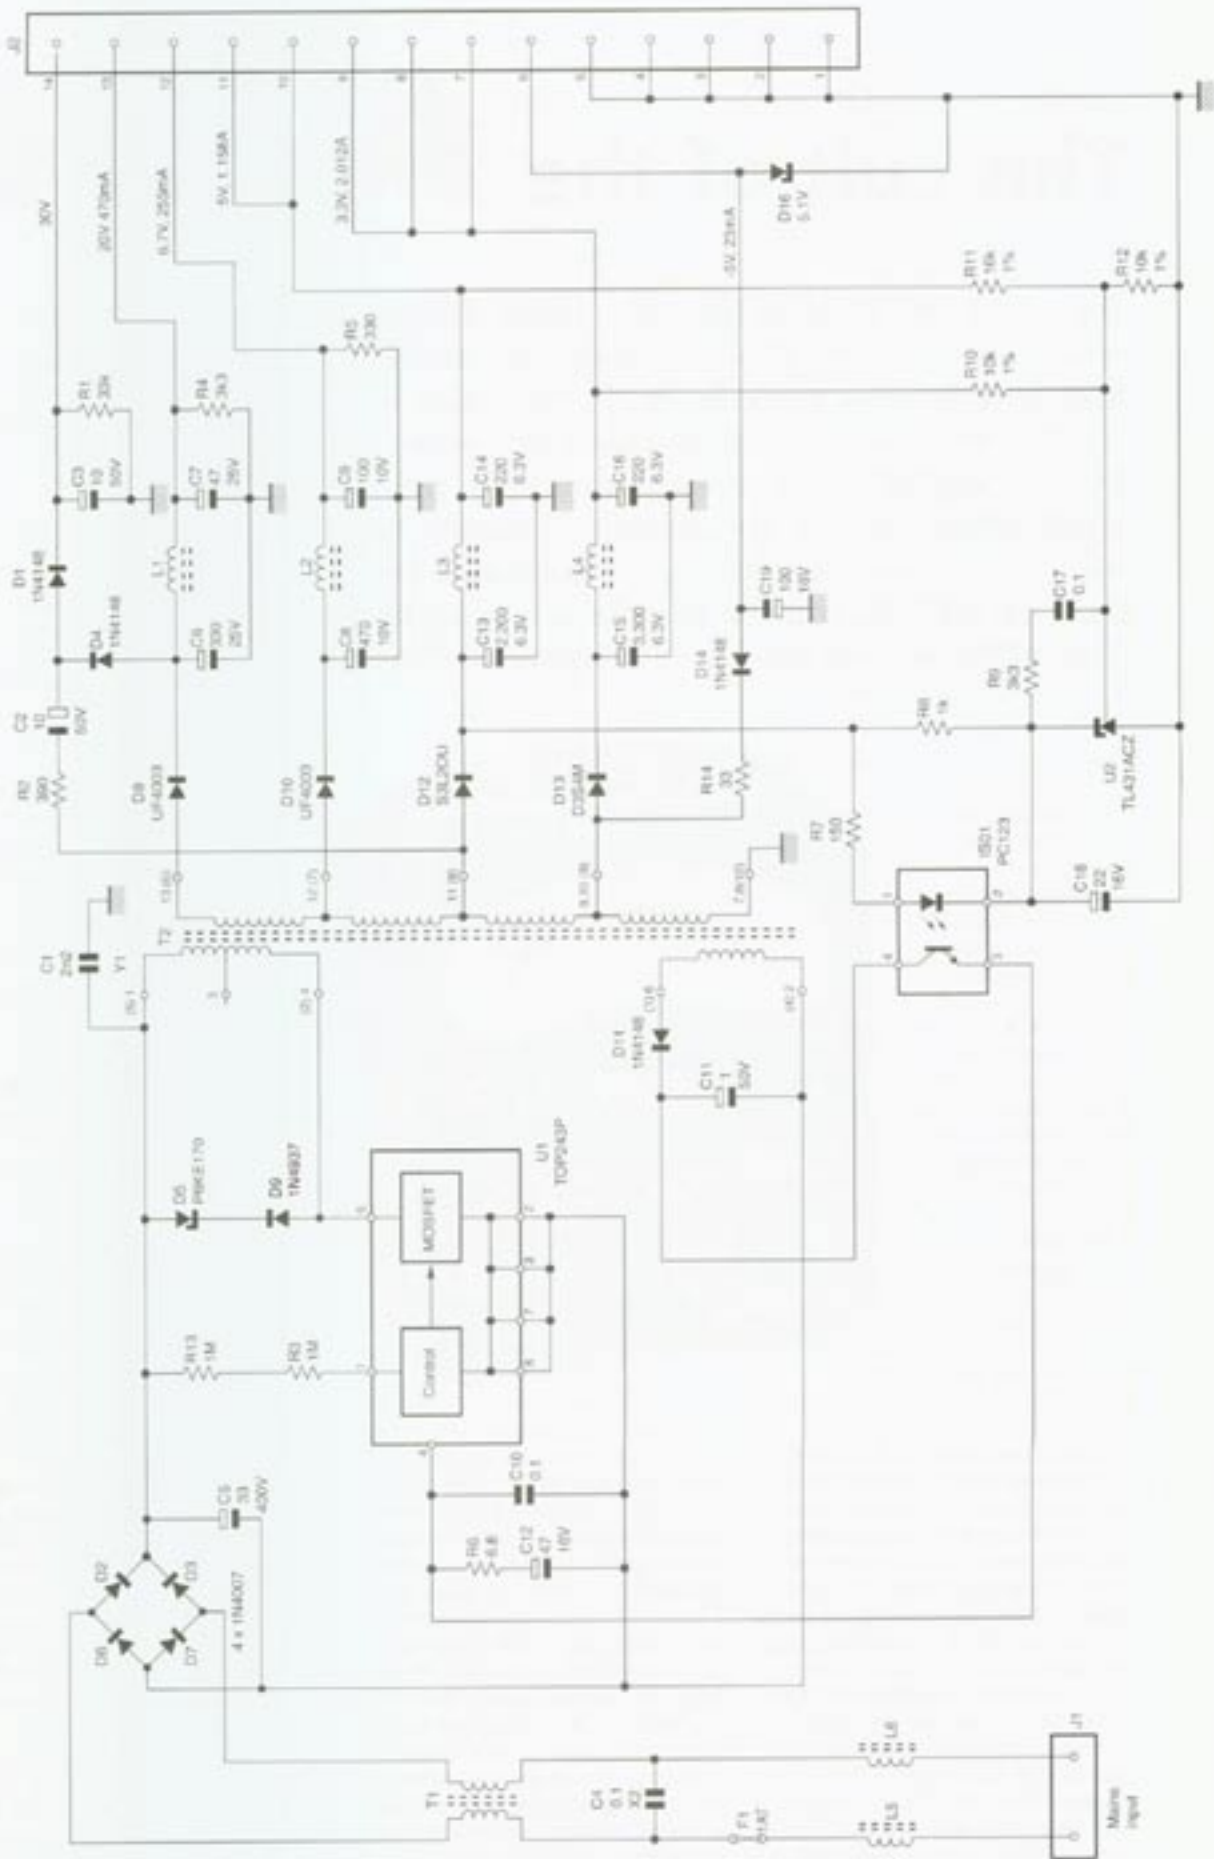
Fig. 1 shows the circuit diagram of the power supply which, in comparison with earlier models, is remarkably simple. It's easy to work on, and fault-diagnosis is simple. There are only a handful of components on the primary side of the power supply, the main one being the TOP243P chopper/control chip U1. Regulation feedback is applied to pin 4 of this IC from the PC123 optocoupler IS01, which is driven by the TL431ACZ adjustable shunt regulator chip U2. The latter monitors the 5V and 3.3V supplies at its reference pin, via 1% resistors.

The only slightly unusual arrangement on the secondary side is the way in which the 30V supply is obtained, by a voltage-doubler circuit (D1, D4, C2, C3) that 'sits' on the unsmoothed 20V supply.

If the power supply is dead with the mains input fuse F1 (1AT) intact, the cause is usually failure of one or both of the 1M $\Omega$  start-up resistors R3 and R13. They should both be replaced, using the 0.75W, 350V metal-film type.

If the mains input fuse is blackened and the top has blown off the chopper chip U1, the cause is the mains bridge rectifier's reservoir capacitor C5 (33 $\mu$ F, 400V). You will find that it's open-circuit. In addition, the 1N4007 mains bridge rectifier diodes D2, D3, D6 and D7, IS01 and the 1N4148 rectifier diode D11 will all have been damaged and will have to be replaced, even if a cold check suggests that they are OK – they can fail at switch on.

Finally there's the most serious fault. This is given away by the presence of a loose object inside the box. You will find that capacitor C6 (330 $\mu$ F, 25V), the reservoir capacitor for the 20V supply, has exploded. The basic cause of this is failure of C13 (2,200 $\mu$ F, 6.3V) or C15 (3,300 $\mu$ F, 6.3V). The

value of either of these two capacitors can fall dramatically. As they are the reservoir capacitors for the 5V and 3.3V supplies respectively, U2 and IS01 think that one of these supplies has fallen and attempt to increase it, with the result that all the supply voltages on the secondary side rise. In this event, because of internal heating nearly all the capacitors on the secondary side of the circuit will have fallen in value. For any chance of long-term reliability, the whole lot must be replaced. Despite this rise of voltages on the secondary side of the circuit, I have yet to find any damage on the main board.

Fig. 1: Circuit diagram of the power supply in the Amstrad digibox Model DRX400. The numbers shown in brackets at the connections to chopper transformer T2 are for an alternative type used in some of these digiboxes.
